Sky Valley Subdivision (Outfall Cascade),  
Subwatershed ID 141.

Sky Valley Subdivision (Pond Outfall),  
Subwatershed ID 141.

South Shore Road (Drainage Conveyance),  
Subwatershed ID 160.

White Oak Drive North Side (Drainage Conveyance),  
Subwatershed ID 123.

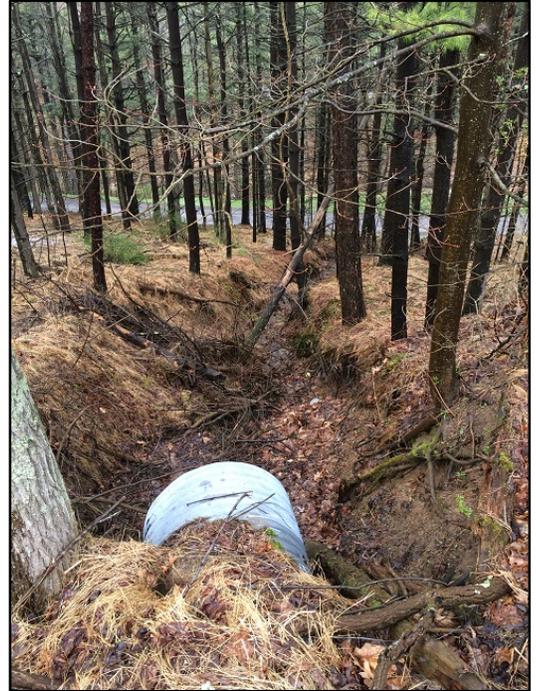
Stormwater runoff is routed through roadside ditches to a 27-inch CMP outfall culvert at the corner of Valley View Drive and Piney Point Drive. There is an additional 24-inch HDPE culvert that collects excess runoff that overtops Piney Point Drive. Runoff from the culvert outfalls flows down to Sky Valley Drive in an eroded channel on the steep hill, which shows significant signs of active incising and tree failure along the channel. Erosion is evident in the receiving ditch along Sky Valley Drive and in the channel receiving flows from the culvert under Sky Valley Drive. The subdivision has three other small drainage outfalls along Valley View Drive that act to divert flow prior to reaching the corner outfall. These have had their capacity limited as the upstream ends of the CMP culverts have been deformed and in some instances shut mostly closed.

The proposed concept design aims to contain and divert as much flow as possible to attenuate peak flows reaching the storm drain outfall at the low point of Piney Point Drive. Additionally, the concept design remediates and stabilizes the receiving channel below the culvert outfall. The concept design involves replacing/restoring flow capacity to the three culverts under Valley View Drive, providing end of pipe protection, and increasing capacity in existing ditches to avoid runoff from overtopping roads and damming flow at driveway culverts, storing and infiltrating stormwater runoff through the use of a vegetated swale with check dams and infiltration trenches, and finally conveying runoff down the steep hill in a controlled and stable manner to prevent bank erosion and channel incising. Two alternatives were evaluated to rehabilitate the steep culvert outfall channel. One alternative is to place a 30-inch flexible HDPE corrugated perforated pipe filled with clean aggregate inside the channel and backfill the channel to natural grade simulating a French drain condition. The pipe would be tied into manholes at

both ends. A second alternative is to construct a series of cascading step-pools in the channel to dissipate the energy and stabilize the banks.

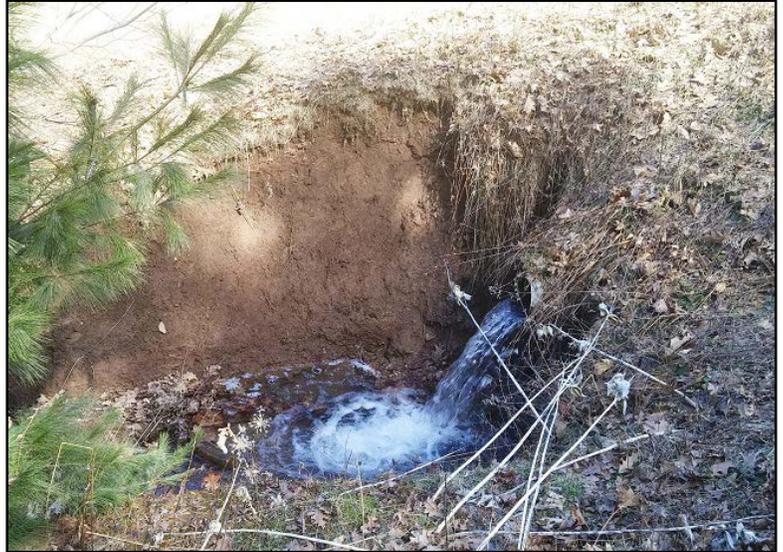
Stormwater runoff from the pond is discharged through a CMP outfall culvert in the vicinity of the corner between Sky Valley Drive and Bench Road. As shown in the picture above, the outfall discharge freefalls from an approximate height of 3 feet to the receiving stream channel. The existing outfall configuration is constantly scouring the channel's bottom which will continue to degrade. The scoured channel and eroding vertical right bank provide sediment loads to Deep Creek Lake.

The proposed concept design aims to stabilize the pond outfall by constructing a step-pool system to transition from the existing pipe elevation down the stream channel elevation. The steep banks will be graded back from the outfall for approximately half the channel length to Bench Road to mimic the slopes of the stable second half of the channel. In order to open up the banks at the outfall without weakening the pond embankment, a precast concrete culvert head wall with apron and wing walls is recommended.

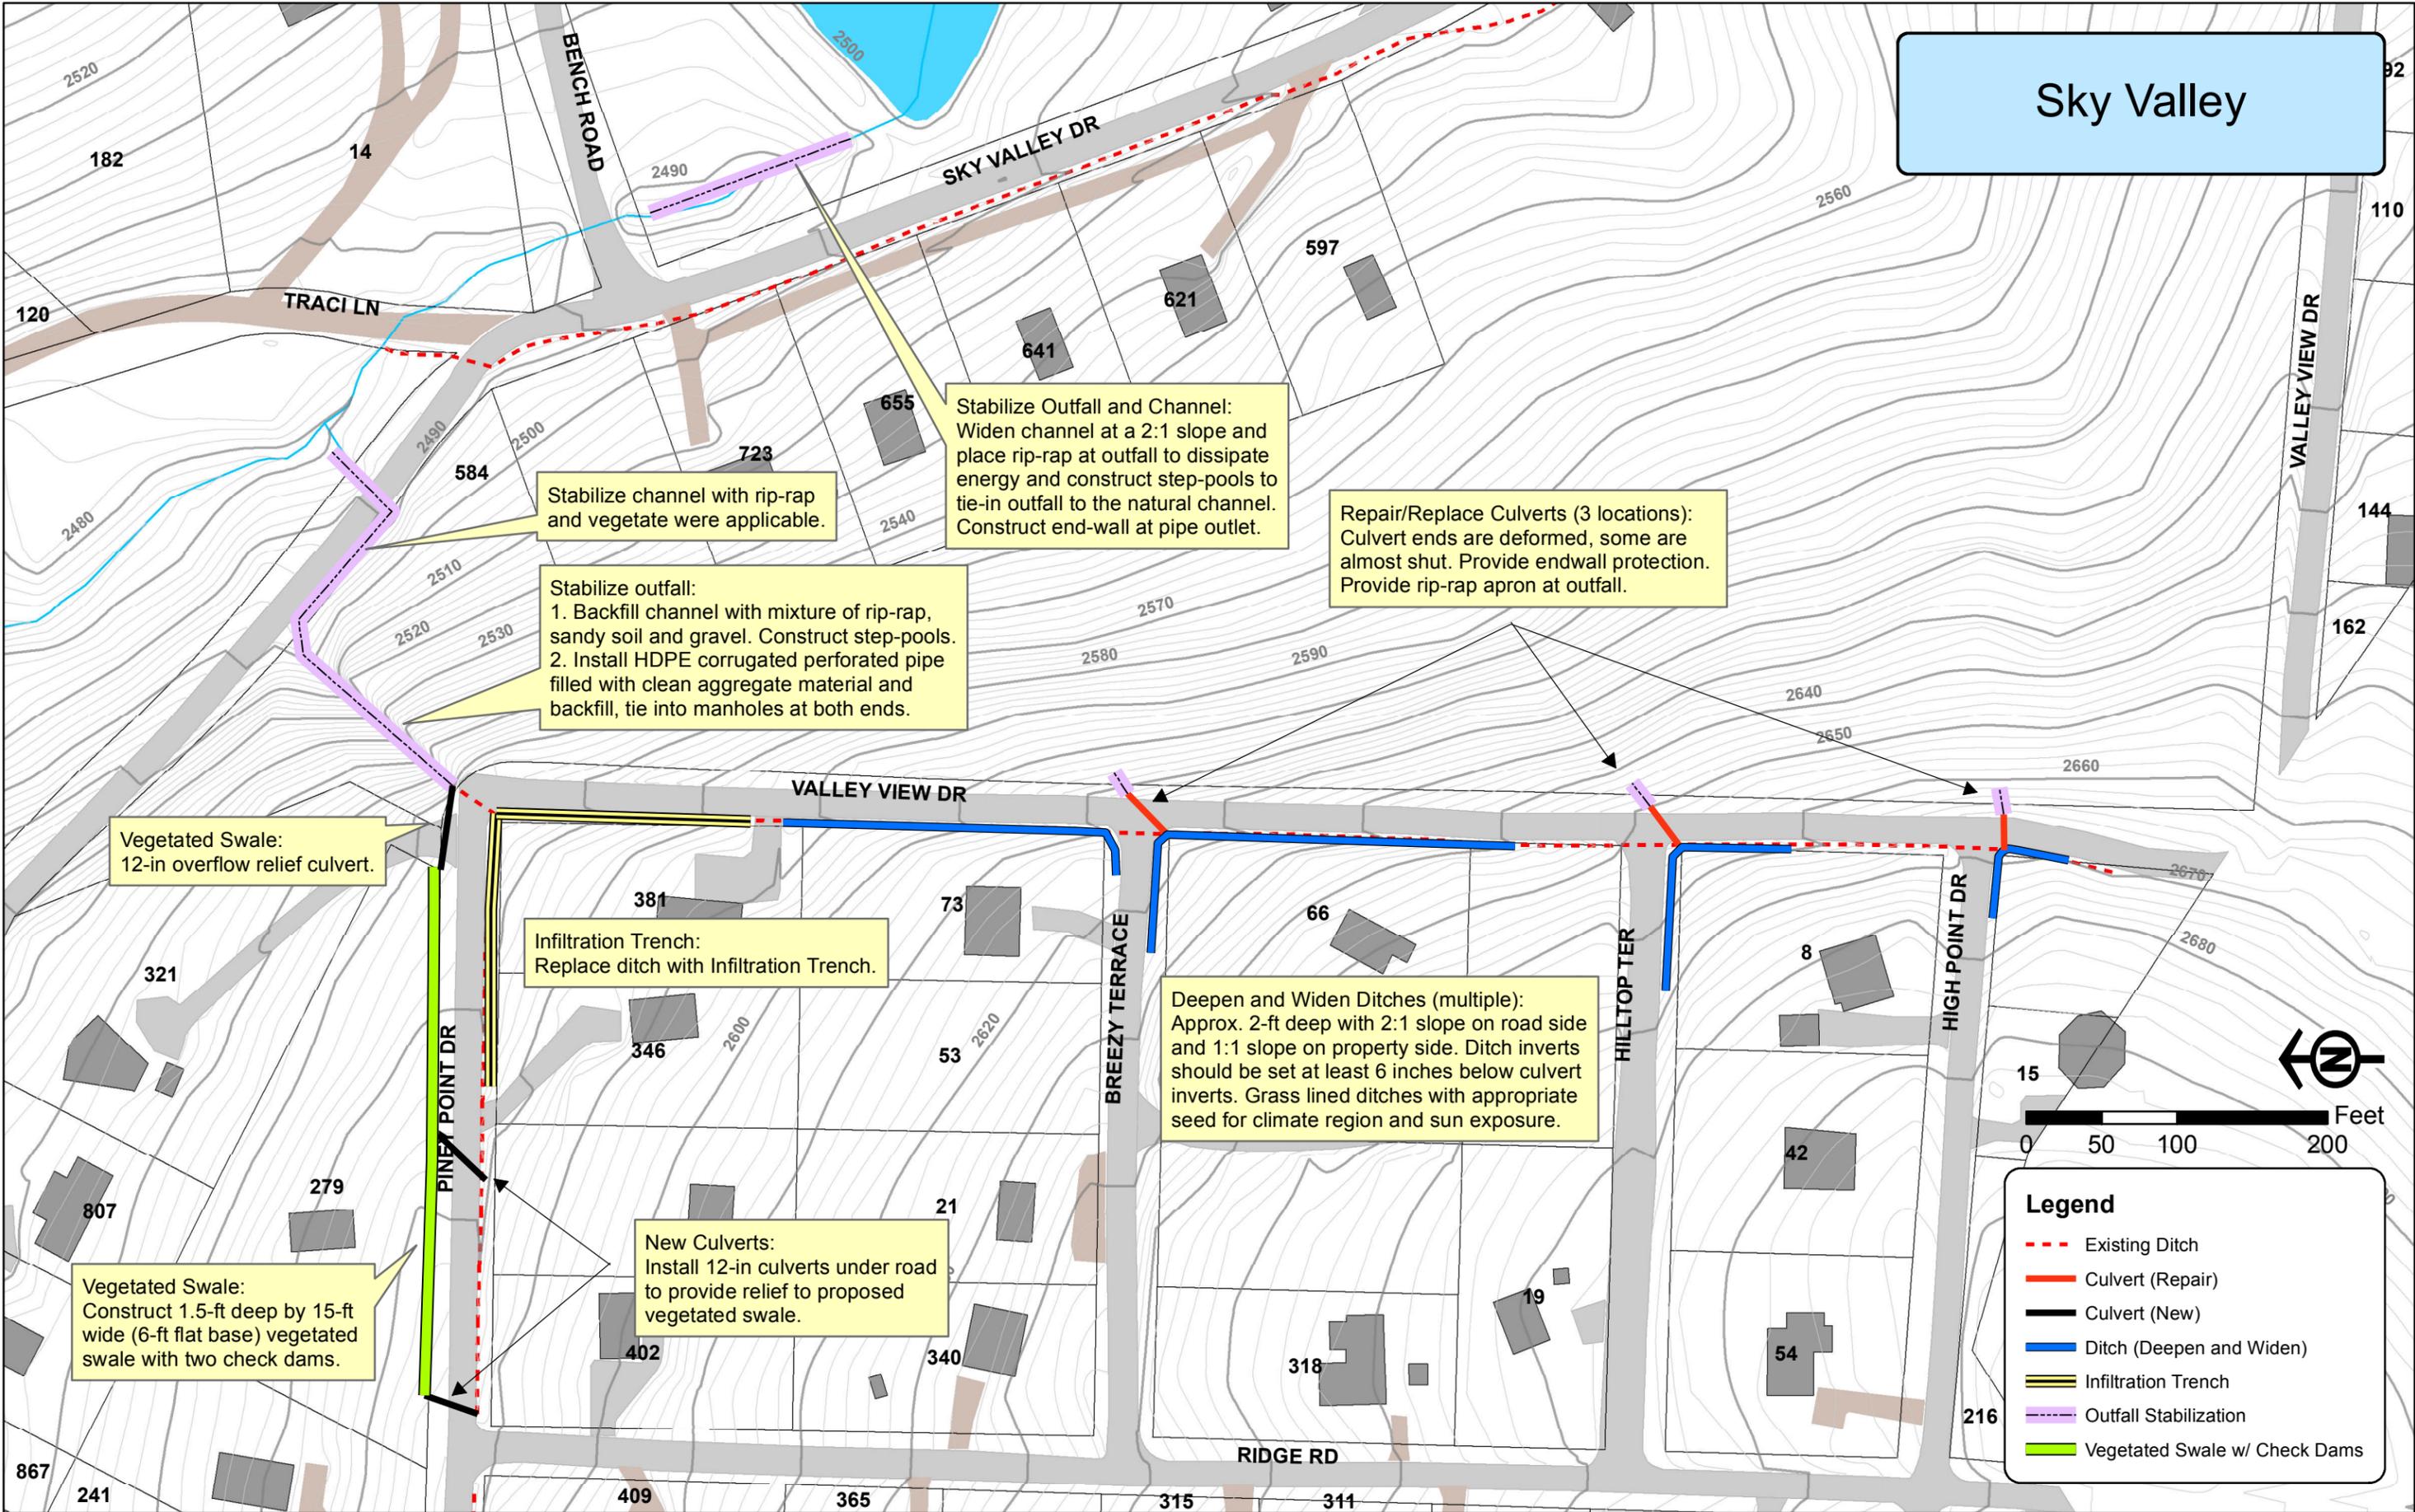
# Sky Valley

Repair/Replace Culverts (3 locations):  
Culvert ends are deformed, some are almost shut. Provide endwall protection. Provide rip-rap apron at outfall.

Stabilize channel with rip-rap and vegetate where applicable.

Stabilize Outfall and Channel:  
Widen channel at a 2:1 slope and place rip-rap at outfall to dissipate energy and construct step-pools to tie-in outfall to the natural channel. Construct end-wall at pipe outlet.

Stabilize outfall:  
1. Backfill channel with mixture of rip-rap, sandy soil and gravel. Construct step-pools.  
2. Install HDPE corrugated perforated pipe filled with clean aggregate material and backfill, tie into manholes at both ends.

Vegetated Swale:  
12-in overflow relief culvert.

Infiltration Trench:  
Replace ditch with Infiltration Trench.

Deepen and Widen Ditches (multiple):  
Approx. 2-ft deep with 2:1 slope on road side and 1:1 slope on property side. Ditch inverts should be set at least 6 inches below culvert inverts. Grass lined ditches with appropriate seed for climate region and sun exposure.

New Culverts:  
Install 12-in culverts under road to provide relief to proposed vegetated swale.

Vegetated Swale:  
Construct 1.5-ft deep by 15-ft wide (6-ft flat base) vegetated swale with two check dams.

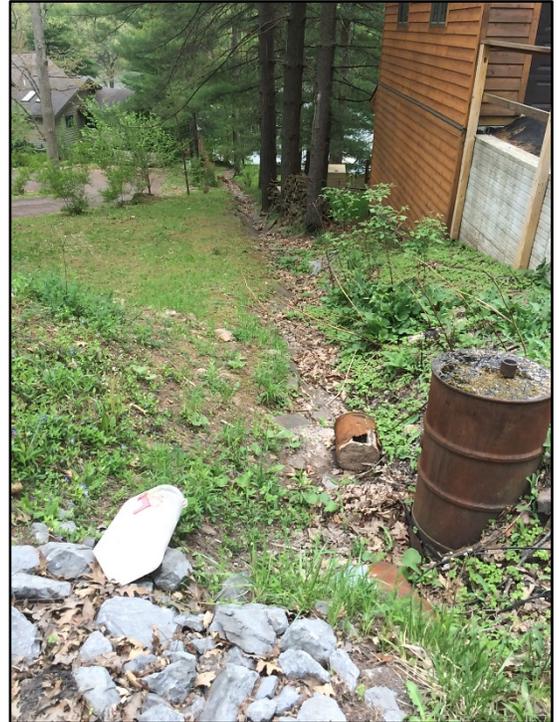
Stormwater runoff from Oak Way Road and South Shore Road is mainly routed by existing ditches to an outfall channel located between the private properties at 190 and 214 South Shore Road. A pipe under the road discharges the ditch-conveyed runoff from the north edge of South Shore Road to the lake side of the road. The outfall channel has been lined with flagstone into a V-shaped channel by the property owners, who are mainly responsible for the channel maintenance as it runs through their property down to the lake. Along South Shore Road, several of the culverts installed under driveways have become deformed and/or partially blocked causing the ditches to overflow across the road and private properties. Harvey Peninsula was developed before stormwater management regulations, therefore, no stormwater management facilities exist. AMT's desktop analysis and field assessments showed the need for improved conveyance in this area as concentrated flows are being routed through private properties with limited runoff controls.

The proposed concept design for this area aims to collect and convey stormwater runoff in a more controlled and stable manner. By combining infiltration techniques with better maintained and deeper ditches along South Shore Road, the concept design objective is to lower peak flow discharges for the more frequent storm events and route them to a storage vault that would release flow at a slower rate to the outfall channel. Storing runoff and reducing the peak discharge allows for more ground infiltration, more groundwater recharge and less erosion and sediment transport to the lake. The storage vault could be constructed under the off-road parking space on 214 South Shore Road.

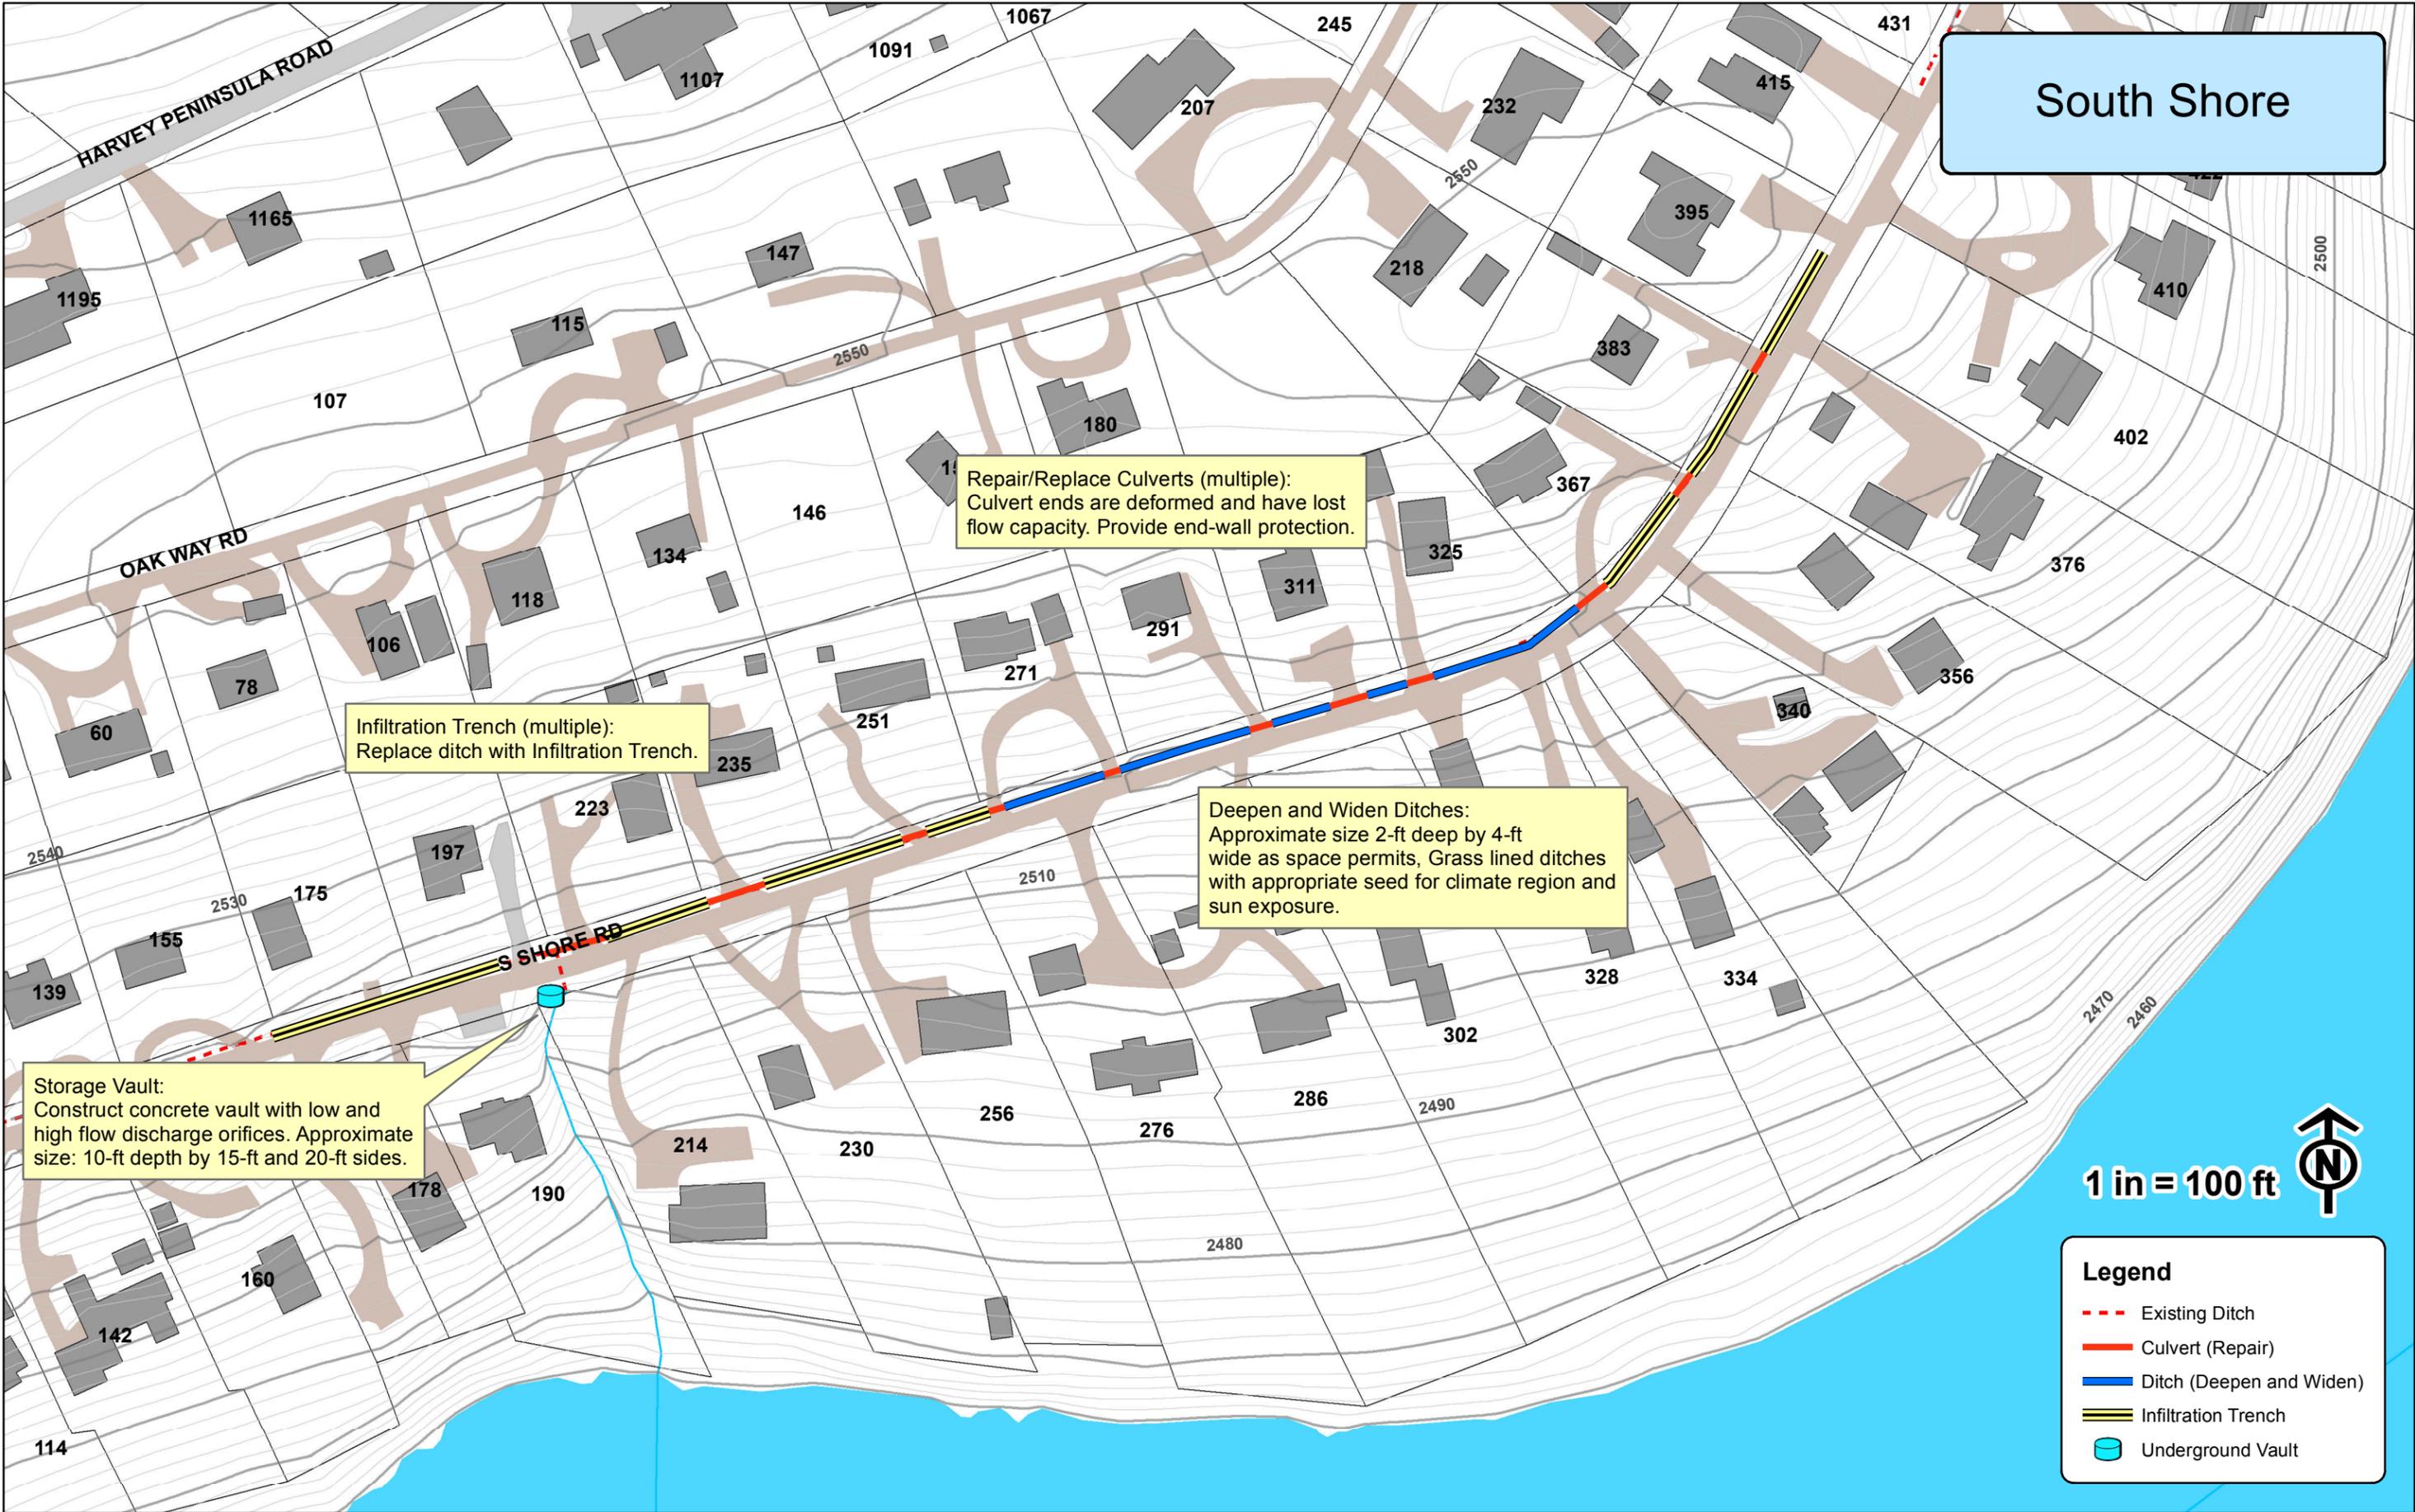
# South Shore

Repair/Replace Culverts (multiple):  
Culvert ends are deformed and have lost flow capacity. Provide end-wall protection.

Infiltration Trench (multiple):  
Replace ditch with Infiltration Trench.

Deepen and Widen Ditches:  
Approximate size 2-ft deep by 4-ft wide as space permits, Grass lined ditches with appropriate seed for climate region and sun exposure.

Storage Vault:  
Construct concrete vault with low and high flow discharge orifices. Approximate size: 10-ft depth by 15-ft and 20-ft sides.

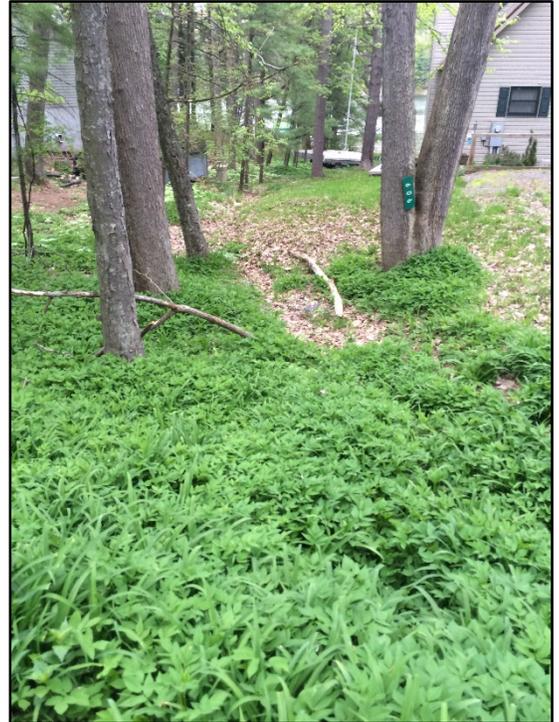
Stormwater runoff from Wooded Ridge Road and White Oak Drive is mainly routed by existing ditches along the western side of White Oak Drive to a culvert crossing the road at approximately 597 White Oak Drive. The outfall discharges onto private property at 606 White Oak Drive where a natural drainage channel has formed conveying the stormwater runoff to Deep Creek Lake. During heavy rainfall events, the property receives highly concentrated flows eroding and depositing sediment onto the front and back yard of the property. Beckham Peninsula was developed before stormwater management regulations, therefore, no stormwater management facilities exist. AMT's desktop analysis and field assessments showed the need for peak flow attenuation in this area as concentrated flows are being routed through private property with limited runoff controls.

The proposed concept design for this area aims to collect and convey stormwater runoff in a more controlled and stable manner. By employing infiltration techniques along White Oak Drive, the concept design will lower peak flow discharges for the more frequent storm events. Capturing some of the runoff allows for groundwater recharge and less erosion and sediment transport to the lake.

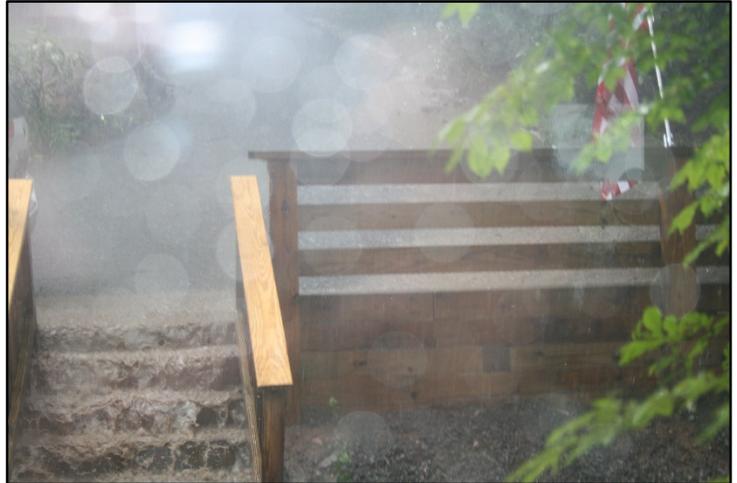
Stormwater runoff from Wooded Ridge Road and White Oak Drive is mainly routed by existing ditches along the northern side of the road to a couple of culverts crossing White Oak Drive. The outfall discharges onto private properties on the lake side of White Oak Drive where natural and/or manmade drainage channels convey the stormwater runoff to Deep Creek Lake. Several of the culverts connecting the ditches under private driveways have become deformed and/or partially blocked causing the ditches to overflow across the road and onto private properties. During heavy rainfall events, some of these properties receive concentrated flows with high flow velocities eroding and depositing sediment onto the front and back yard of private properties. Beckham Peninsula was developed before stormwater management regulations, therefore, no stormwater management facilities exist. AMT's desktop analysis and field assessments showed the need for improved conveyance and peak flow attenuation in the area as concentrated flows are routed through private properties with limited runoff controls.

The proposed concept design for this area aims to collect and convey stormwater runoff in a more controlled manner and disperse concentrated flows through multiple culverts. By combining infiltration techniques and increasing capacity of ditches along White Oak Drive, the concept design will lower peak flow discharges in each channel for the more frequent storm events by installing multiple outfalls.

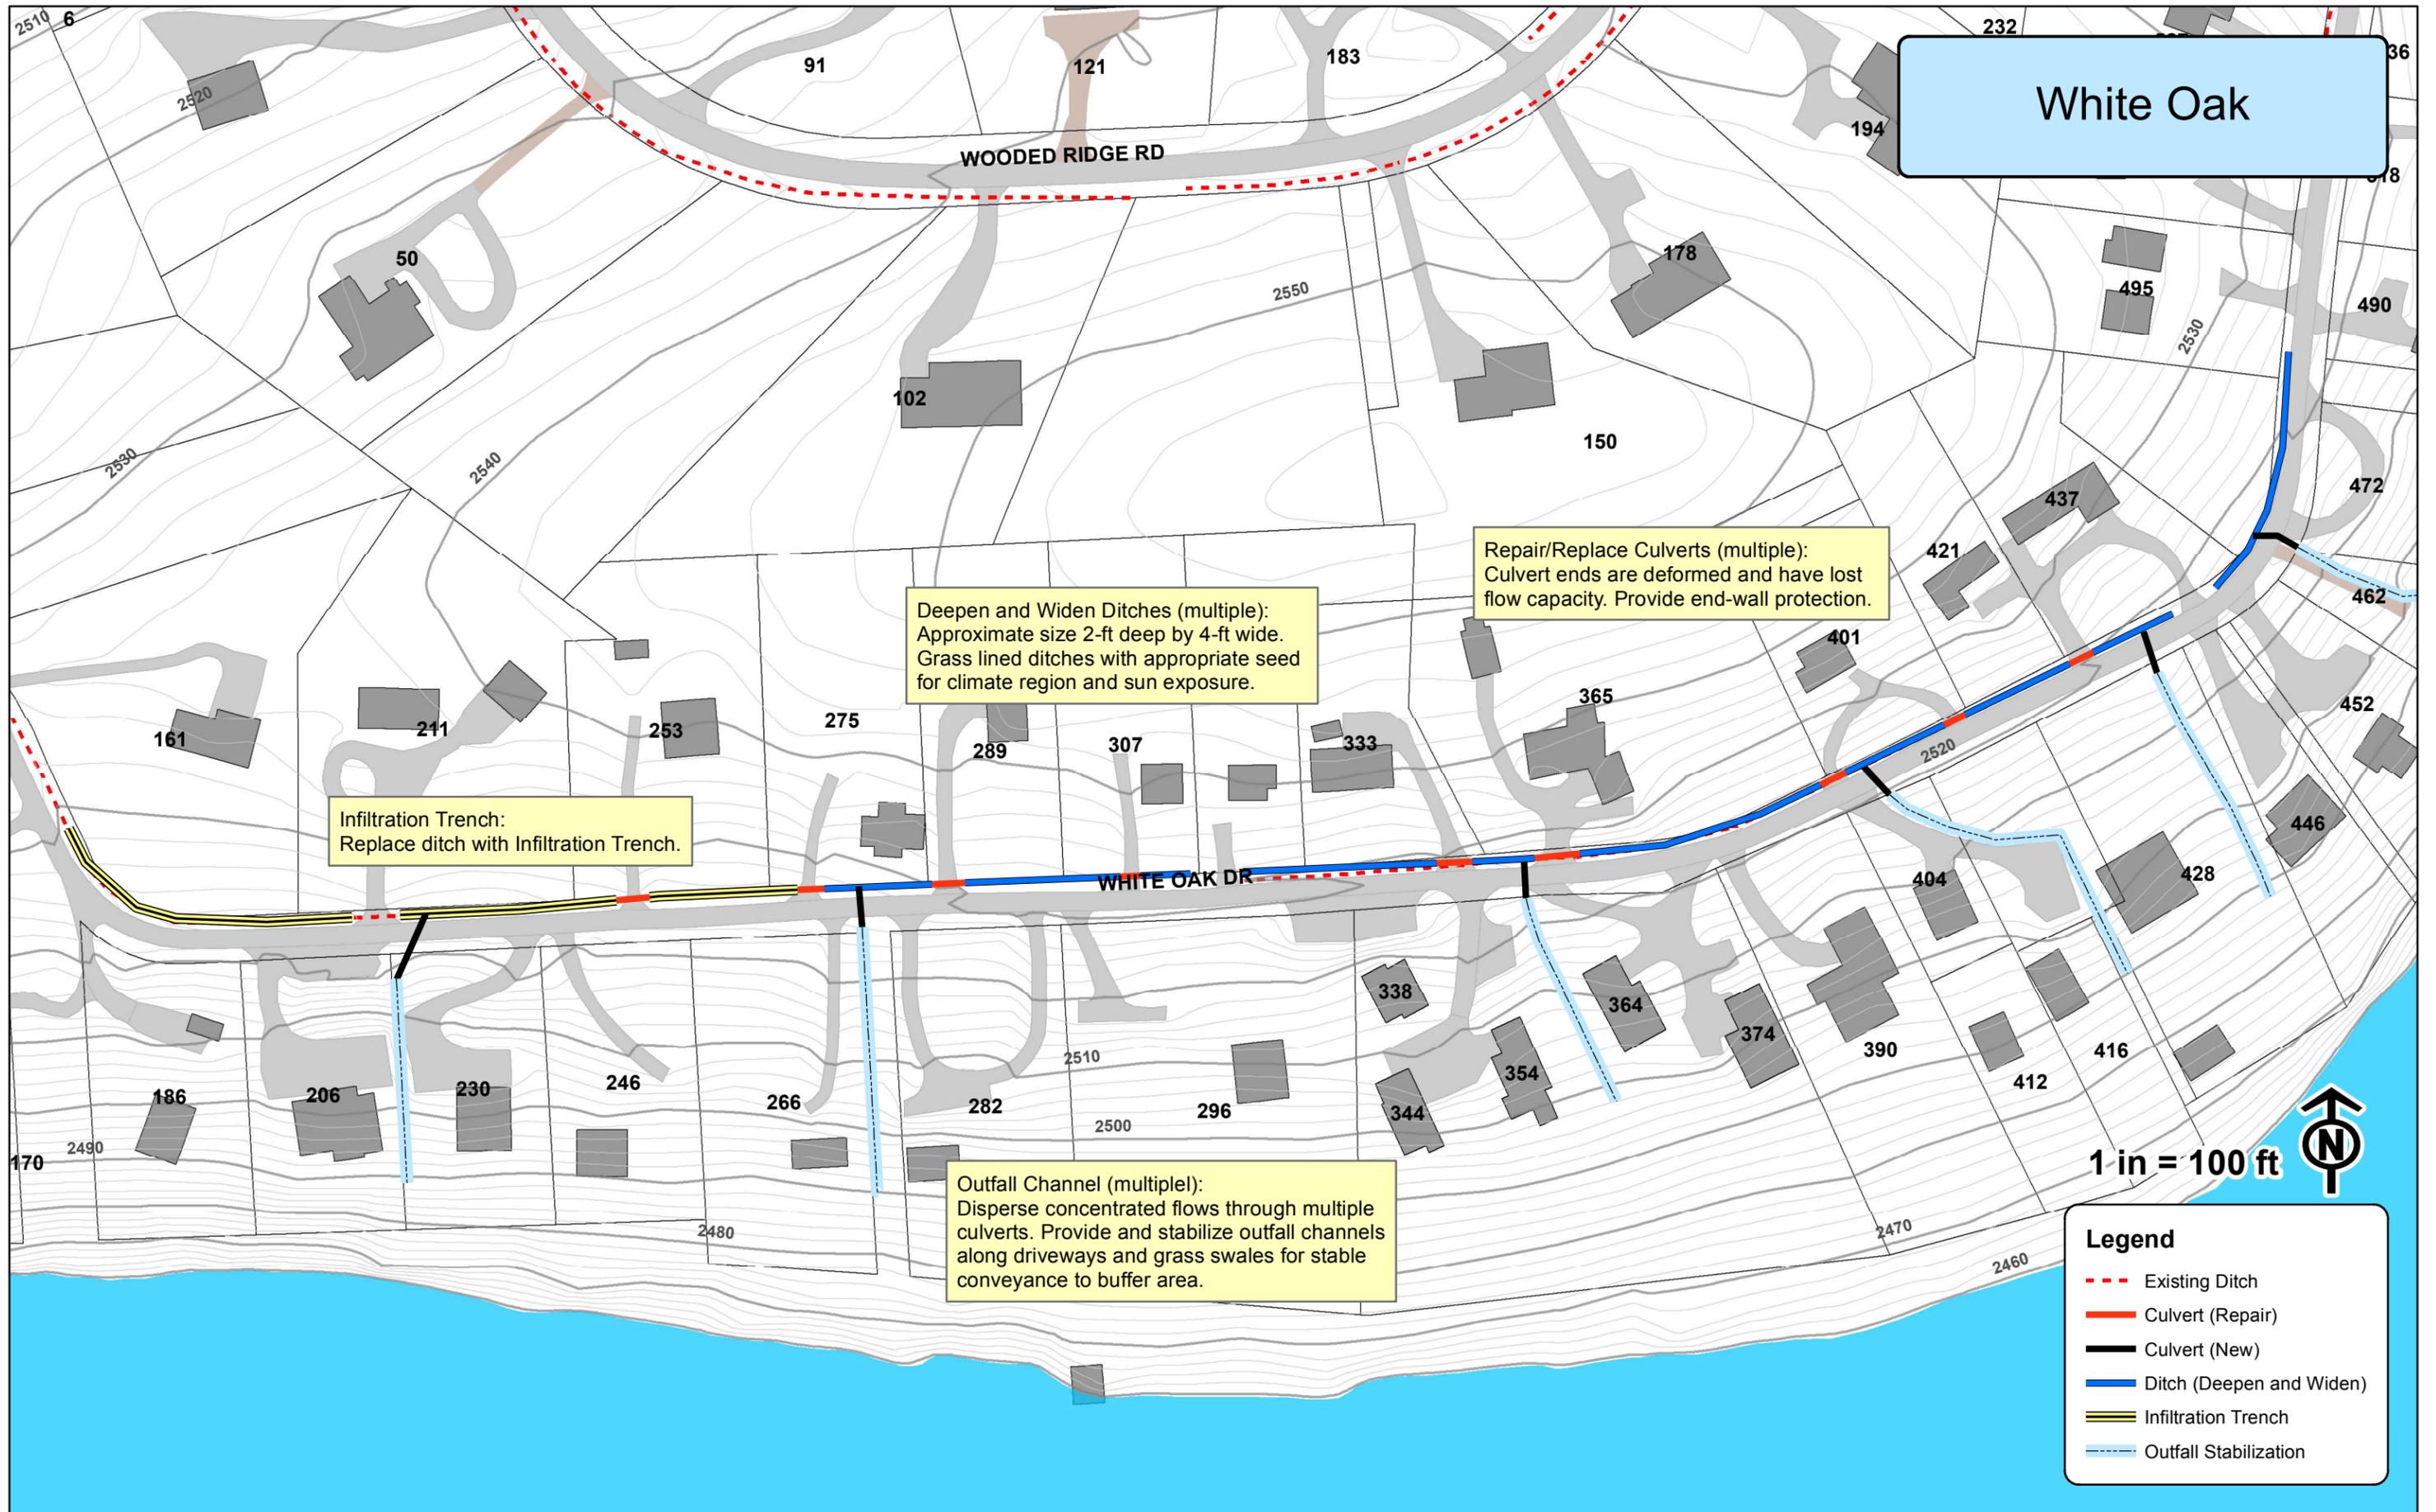
# White Oak

**Repair/Replace Culverts (multiple):**  
Culvert ends are deformed and have lost  
flow capacity. Provide end-wall protection.

**Infiltration Trench:**  
Replace ditch with Infiltration Trench.

**Deepen and Widen Ditches (multiple):**  
Approximate size 2-ft deep by 4-ft wide.  
Grass lined ditches with appropriate seed  
for climate region and sun exposure.

**Outfall Channel (multiple):**  
Disperse concentrated flows through multiple  
culverts. Provide and stabilize outfall channels  
along driveways and grass swales for stable  
conveyance to buffer area.

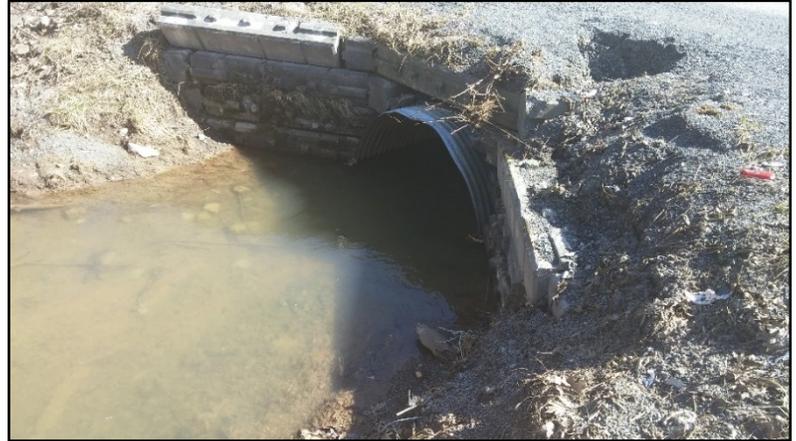
The tributary to North Glade Run that runs through the CMP culvert under North Glade Road represents the second biggest tributary to Deep Creek Lake within the North Glade Run watershed. The stream collects and routes stormwater runoff from the northeastern agricultural and residential areas of the watershed. Field assessments, hydrologic and hydraulic analyses showed that the CMP culvert under North Glade Road is undersized and that the road overtops under the 10-yr storm event. The upstream and downstream culvert headwalls and embankment show clear signs of overtopping and structural failure.

The proposed concept design for the culvert recommends replacing the existing CMP culvert with a double barrel 36-inch RCP culvert with concrete headwalls. Upsizing the road culvert will not only increase road safety, but will eliminate road overtopping under frequent storm events and the corresponding embankment and streambank erosion currently occurring.

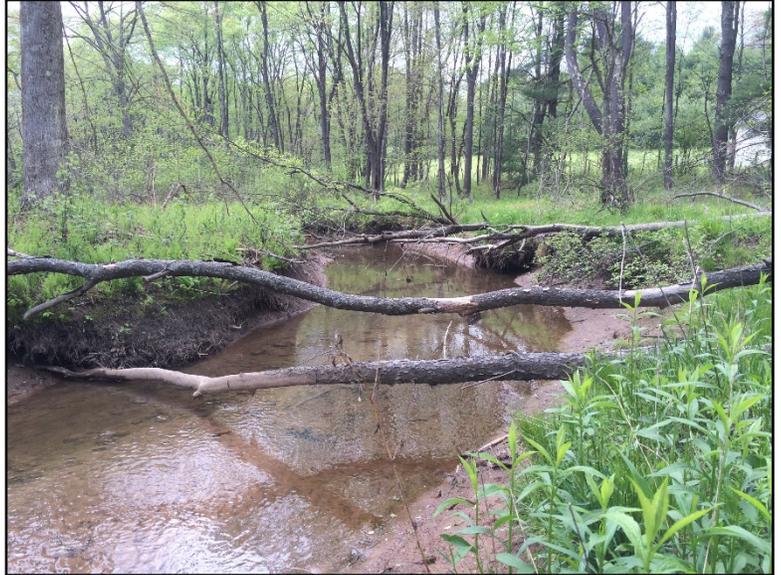
North Glade Run represents the greatest source of stormwater runoff within the North Glade Run watershed tributary to Deep Creek Lake. The stream collects and routes stormwater runoff from the eastern part of the watershed, which lands are mainly used for agricultural purposes. Field assessment of the reach downstream of North Glade Road showed signs indicative of a degrading stream reach. Active channel widening and incising signs were observed along with multiple fallen and undercut trees. This stream reach, being the main lake influent in the watershed, presents the greatest opportunity to reduce sediment and nutrient loadings into Deep Creek Lake.

A proposed stream restoration design for this reach of North Glade Run would have as objectives to stabilize the eroding streambanks and to provide sediment and nutrient removal measures. By use of stream restoration techniques including in-stream structures, bank stabilization and floodplain reconnection, water quality will be increased and sediment loads into Deep Creek Lake will be reduced.

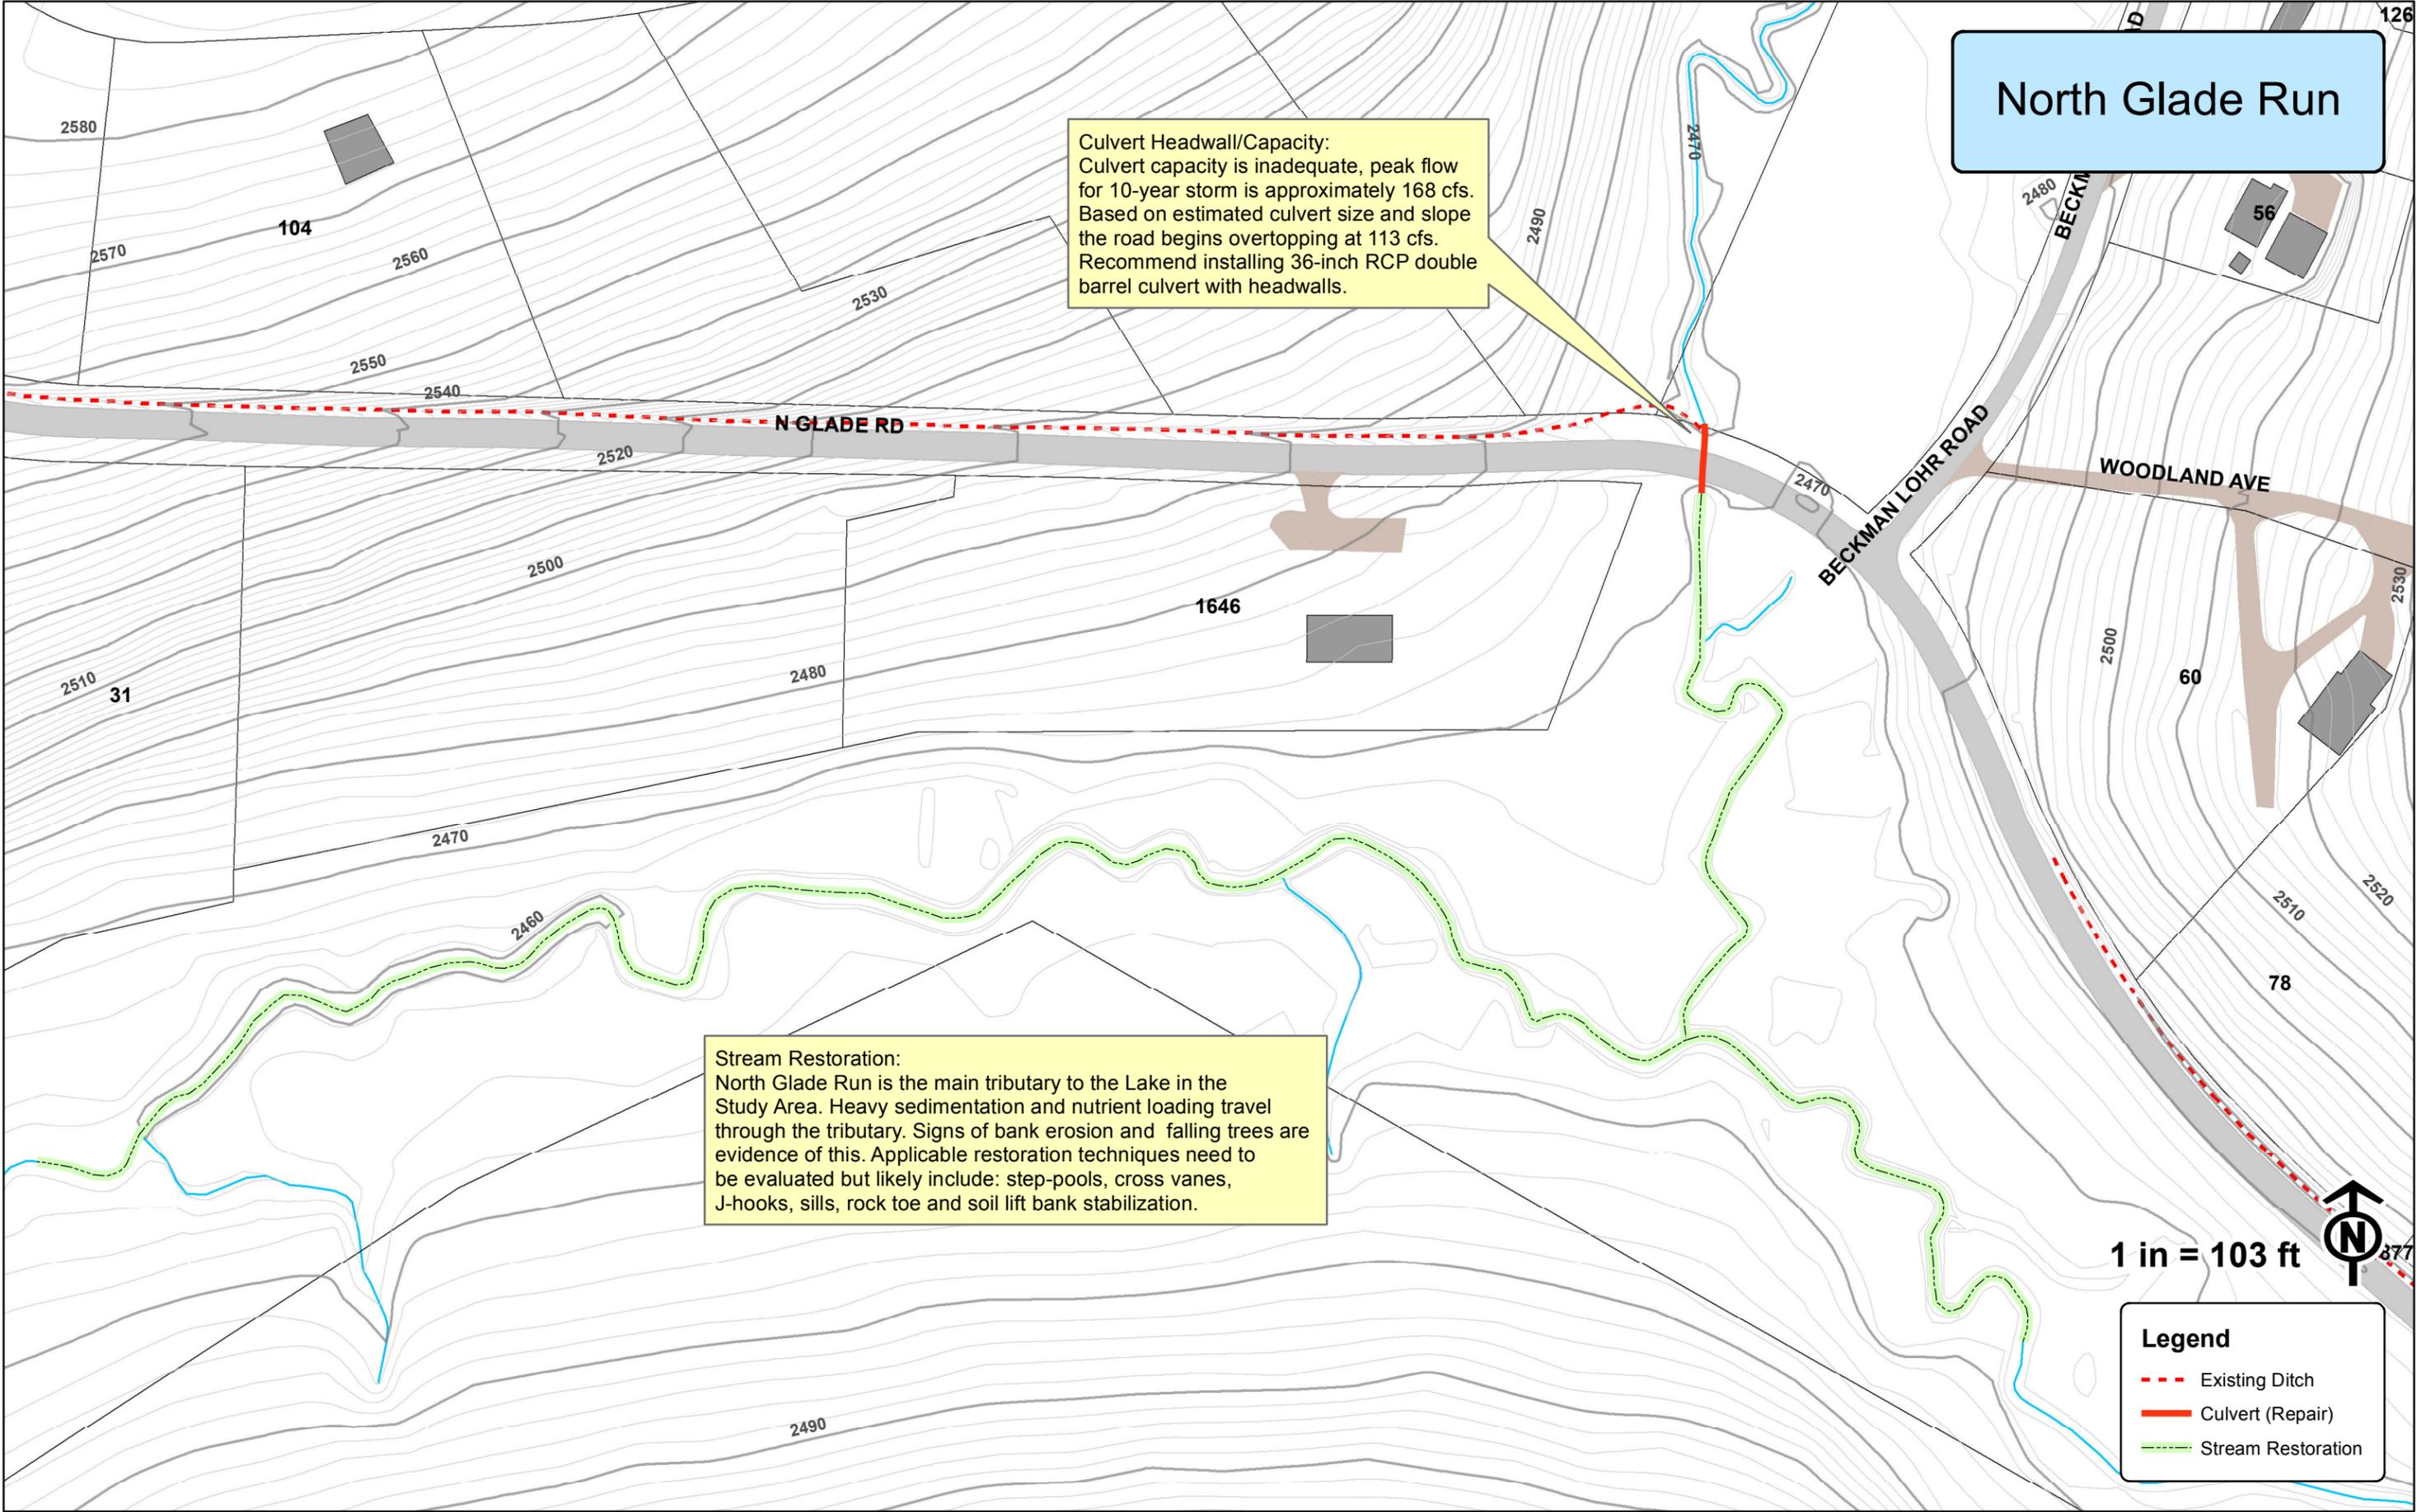
# North Glade Run

**Culvert Headwall/Capacity:**  
Culvert capacity is inadequate, peak flow for 10-year storm is approximately 168 cfs. Based on estimated culvert size and slope the road begins overtopping at 113 cfs. Recommend installing 36-inch RCP double barrel culvert with headwalls.

**Stream Restoration:**  
North Glade Run is the main tributary to the Lake in the Study Area. Heavy sedimentation and nutrient loading travel through the tributary. Signs of bank erosion and falling trees are evidence of this. Applicable restoration techniques need to be evaluated but likely include: step-pools, cross vanes, J-hooks, sills, rock toe and soil lift bank stabilization.
