Sky Valley Subdivision (Outfall Cascade),  
Subwatershed ID 141.

Sky Valley Subdivision (Pond Outfall),  
Subwatershed ID 141.

South Shore Road (Drainage Conveyance),  
Subwatershed ID 160.

White Oak Drive North Side (Drainage Conveyance),  
Subwatershed ID 123.

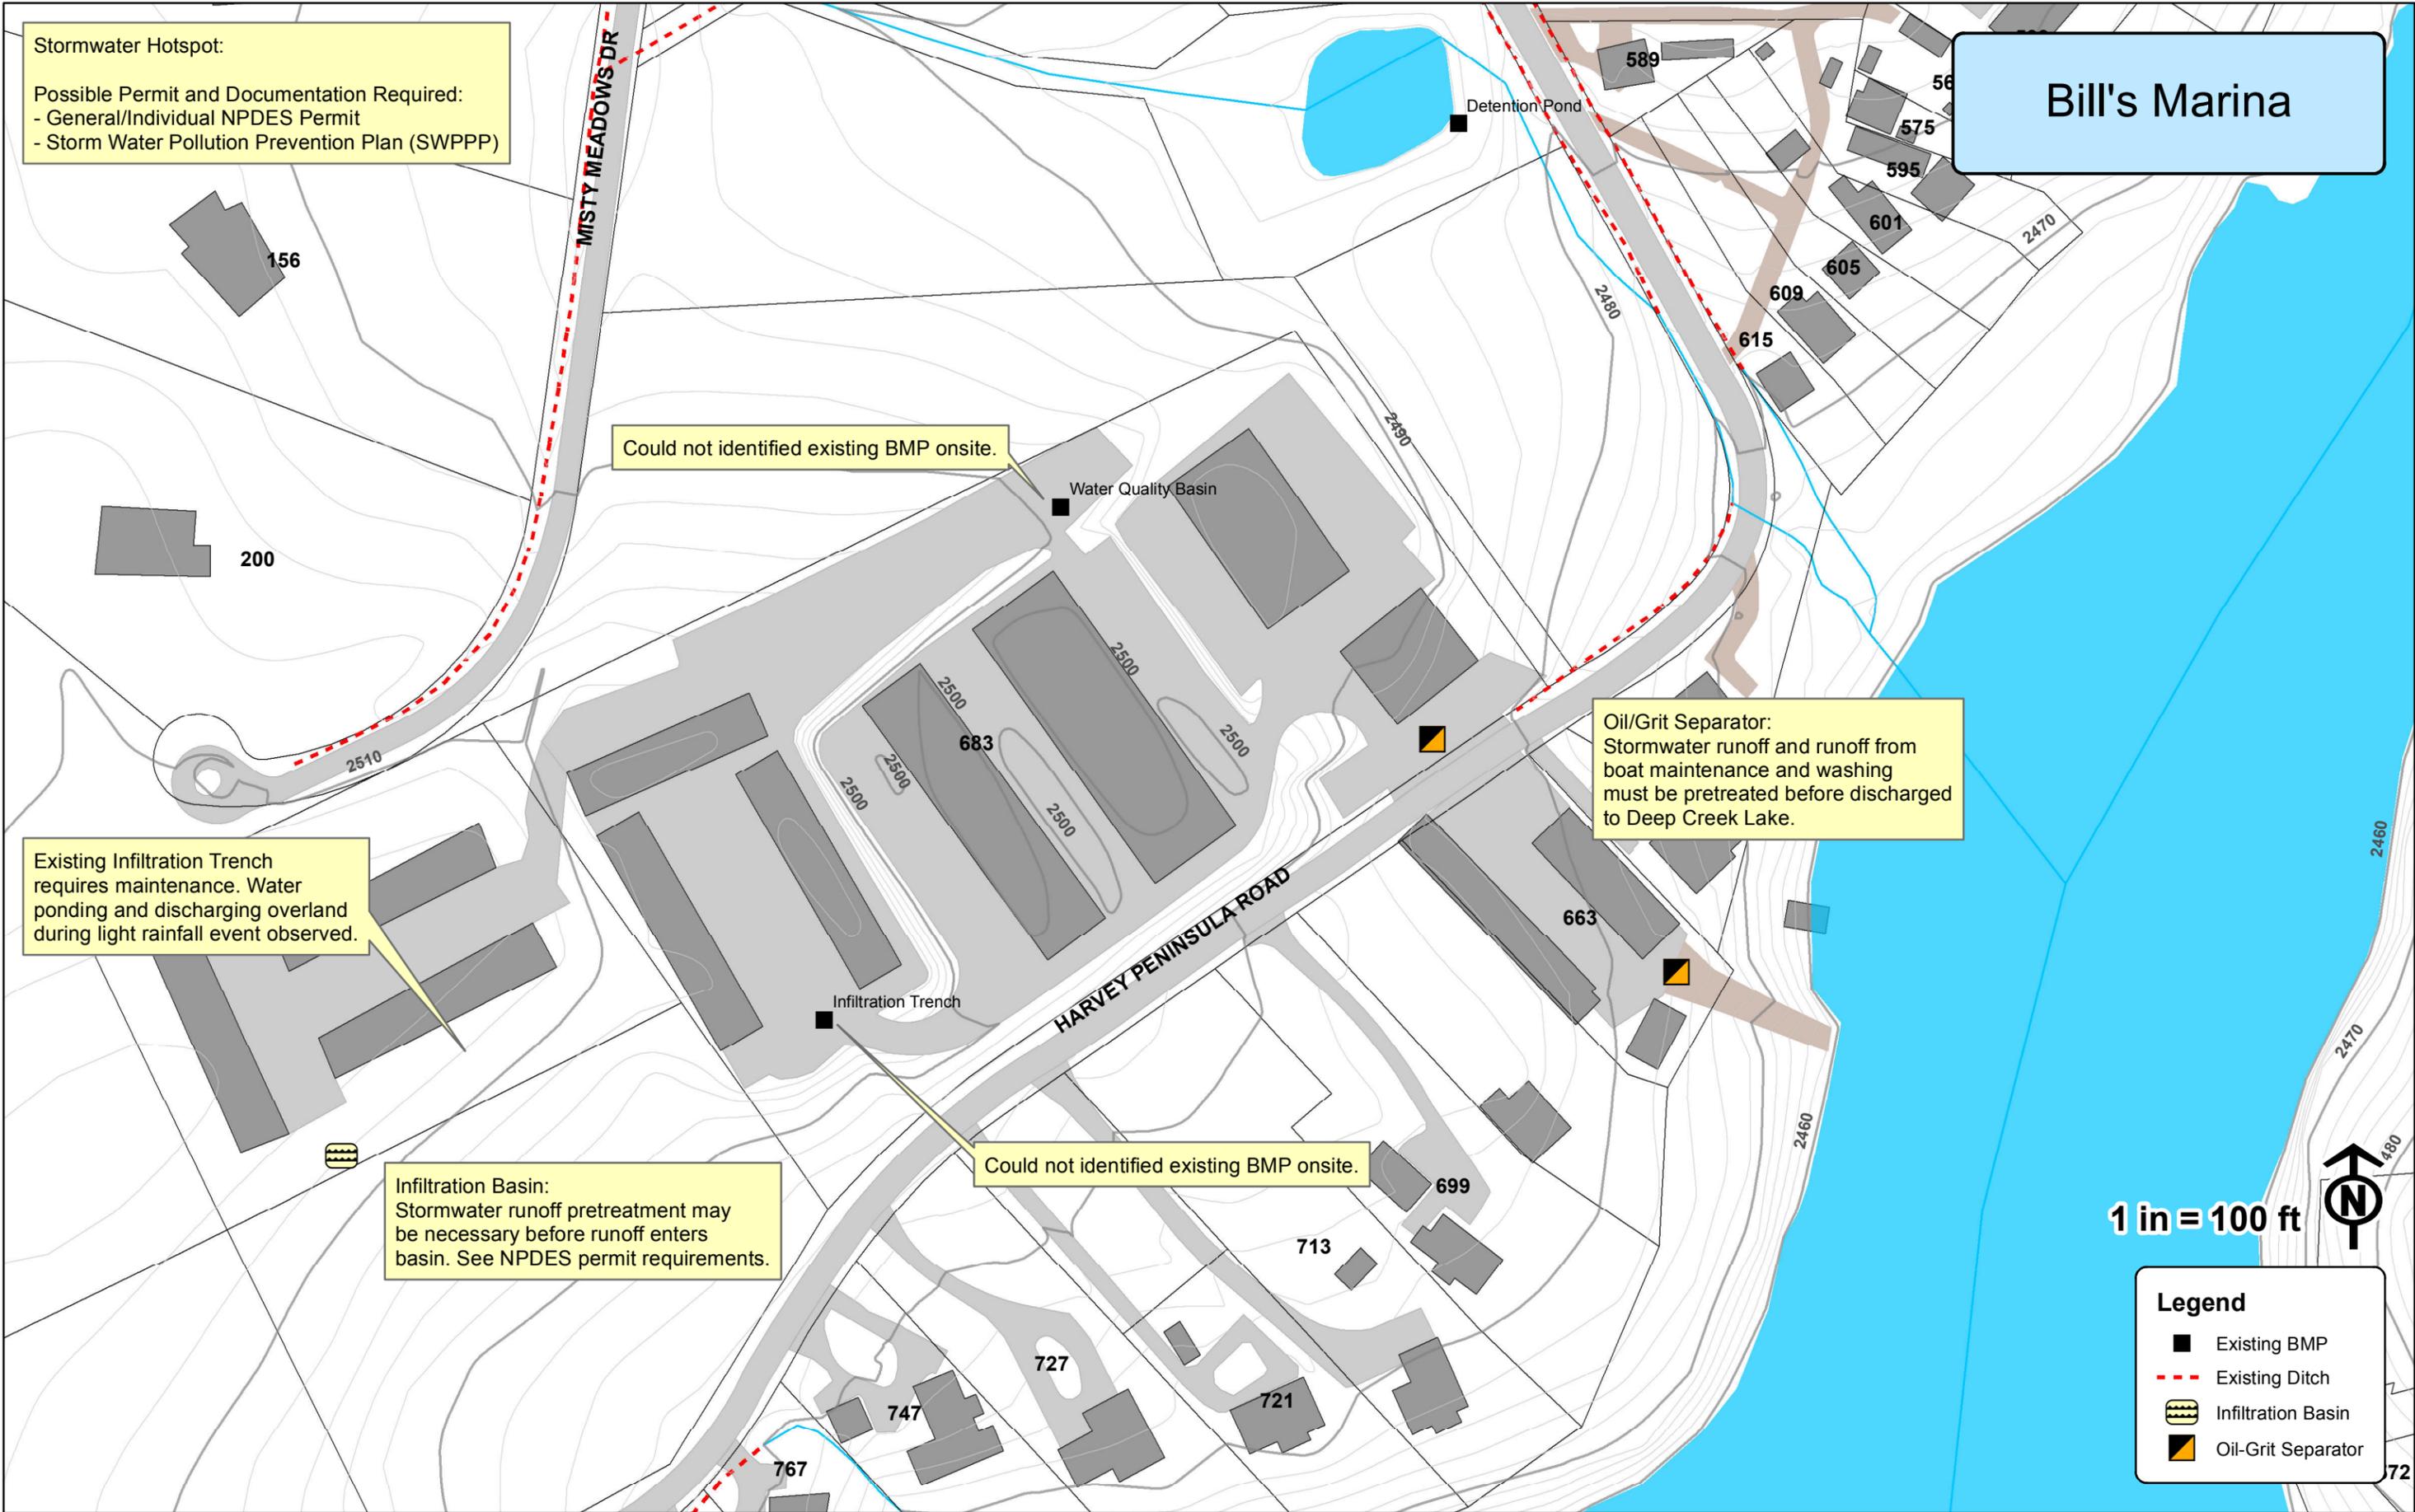
Bill's Marina

Could not identified existing BMP onsite.

Existing Infiltration Trench  
requires maintenance. Water  
ponding and discharging overland  
during light rainfall event observed.

Infiltration Basin:  
Stormwater runoff pretreatment may  
be necessary before runoff enters  
basin. See NPDES permit requirements.

Stormwater Hotspot:  
Possible Permit and Documentation Required:  
- General/Individual NPDES Permit  
- Storm Water Pollution Prevention Plan (SWPPP)

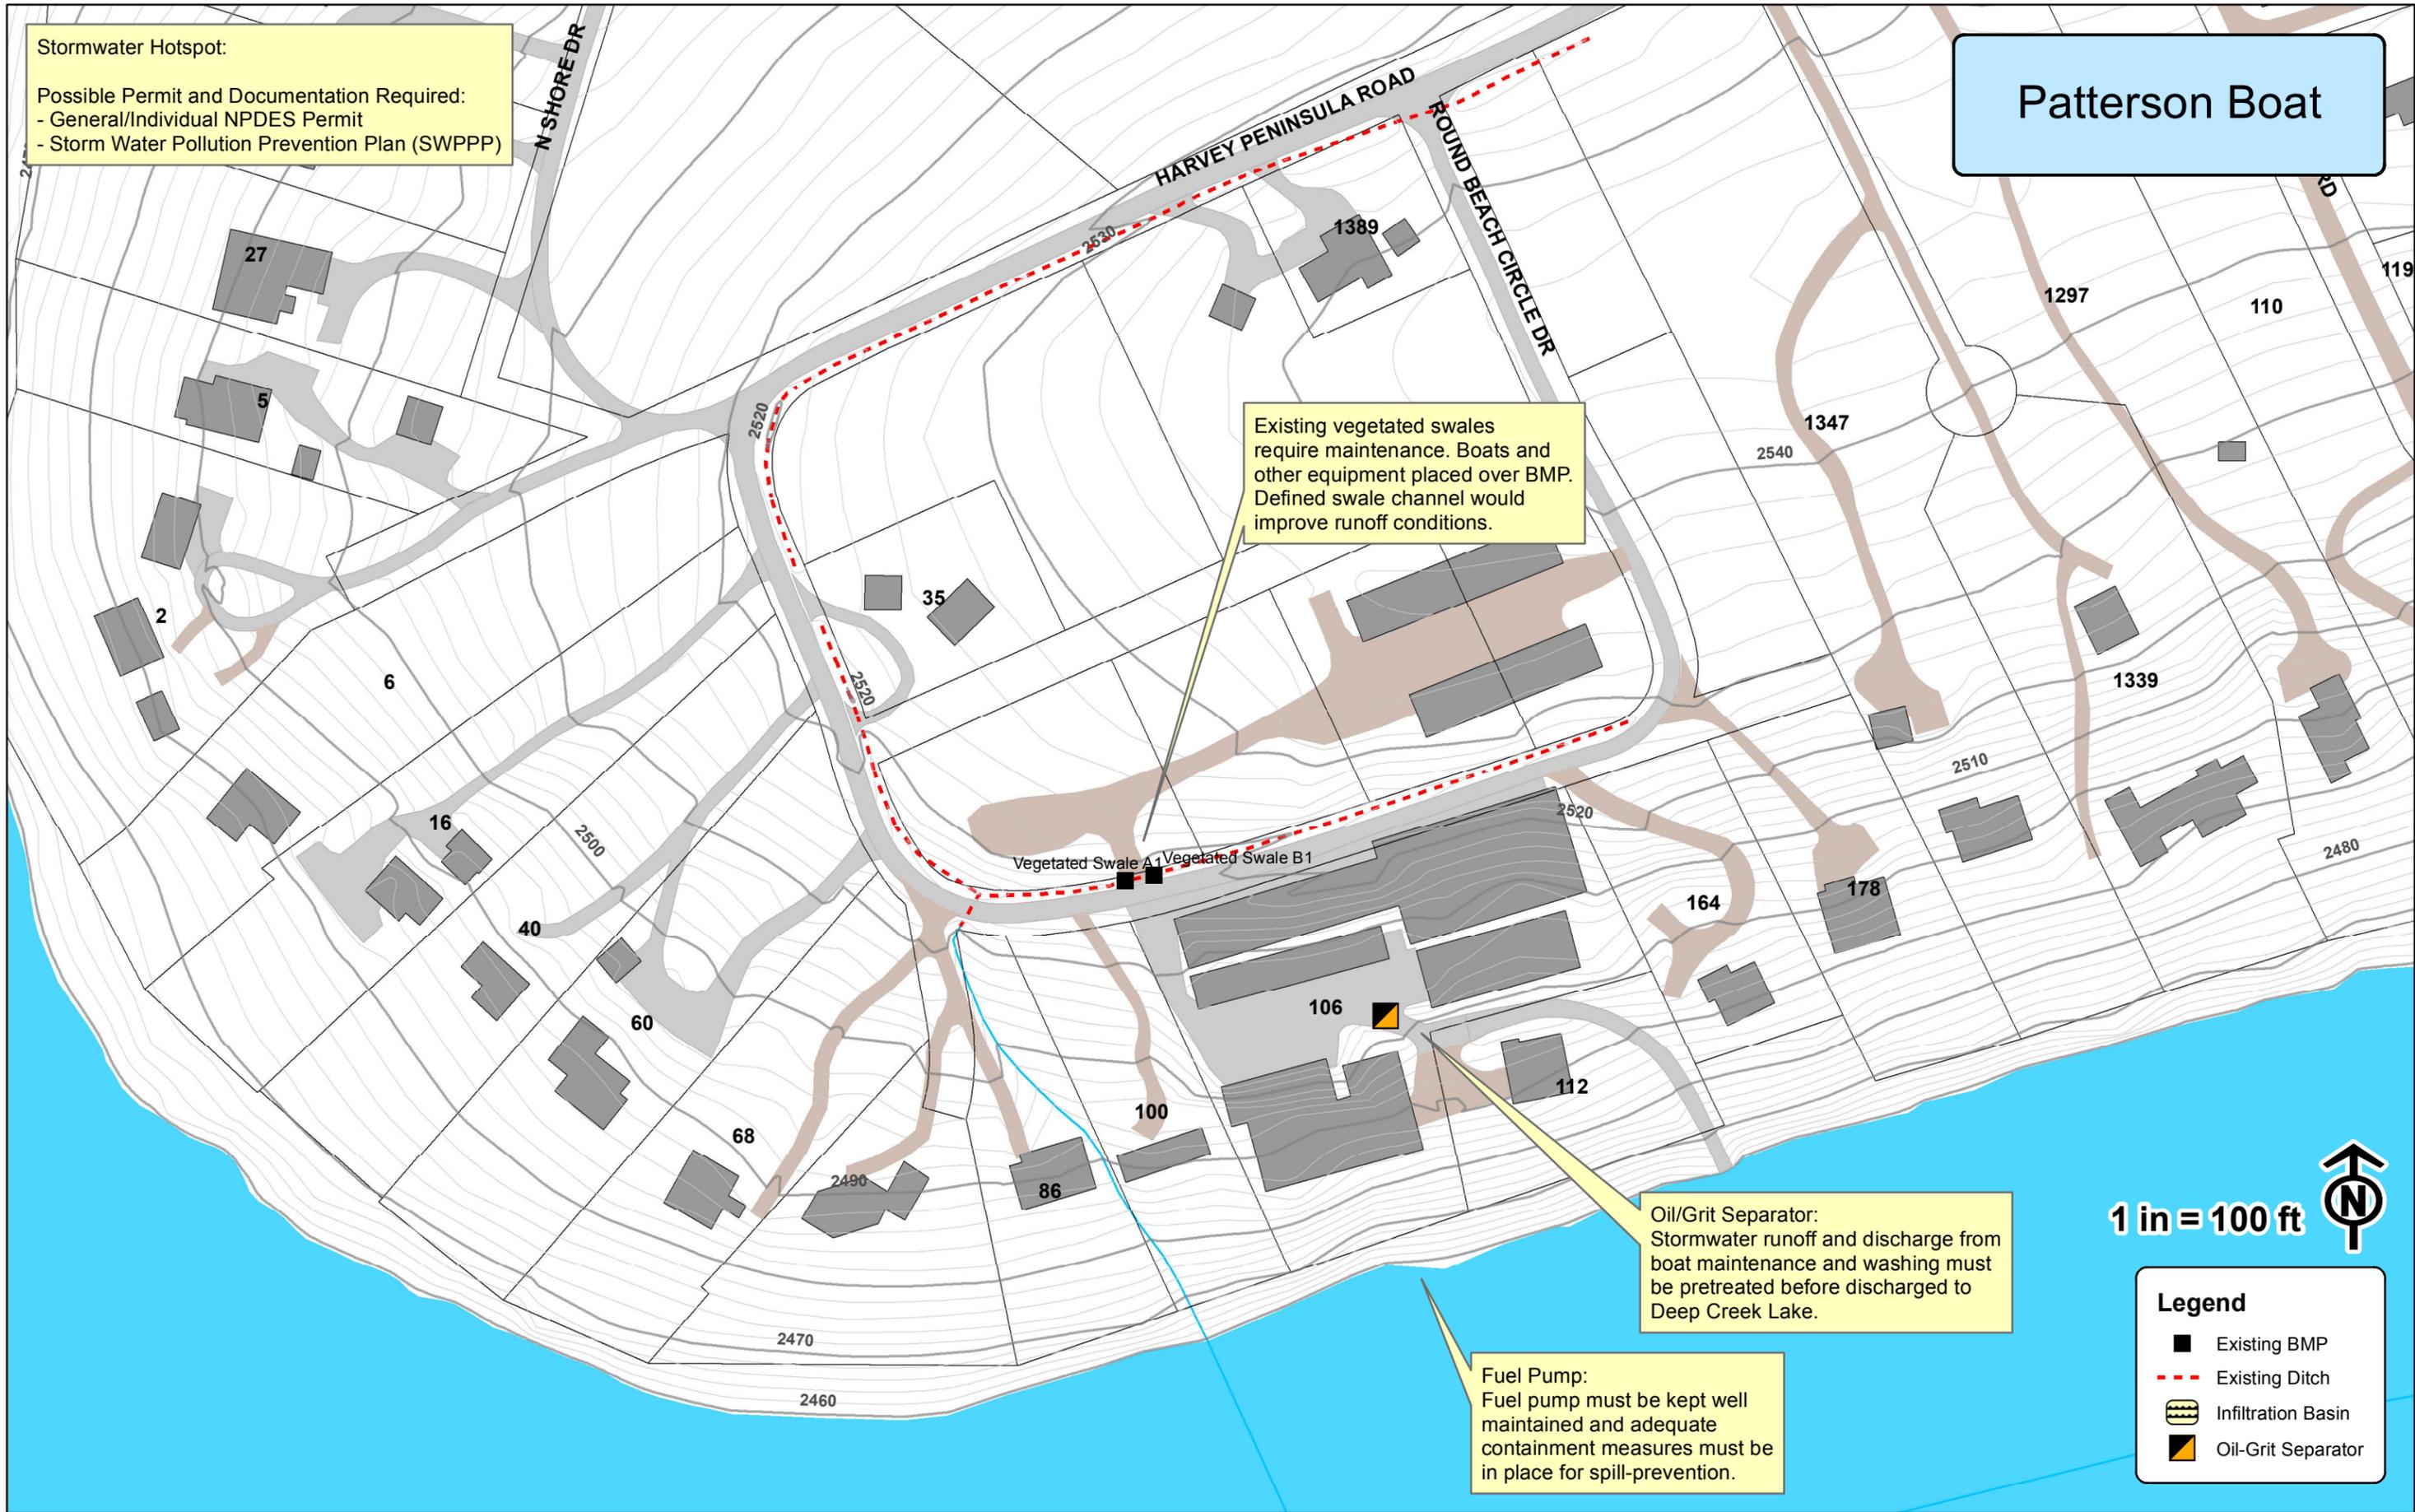
Patterson Boat

Existing vegetated swales require maintenance. Boats and other equipment placed over BMP. Defined swale channel would improve runoff conditions.
