North Glade Run Stormwater Assessment Process

NGR Stormwater Assessment Process

NGR Watershed Characterization

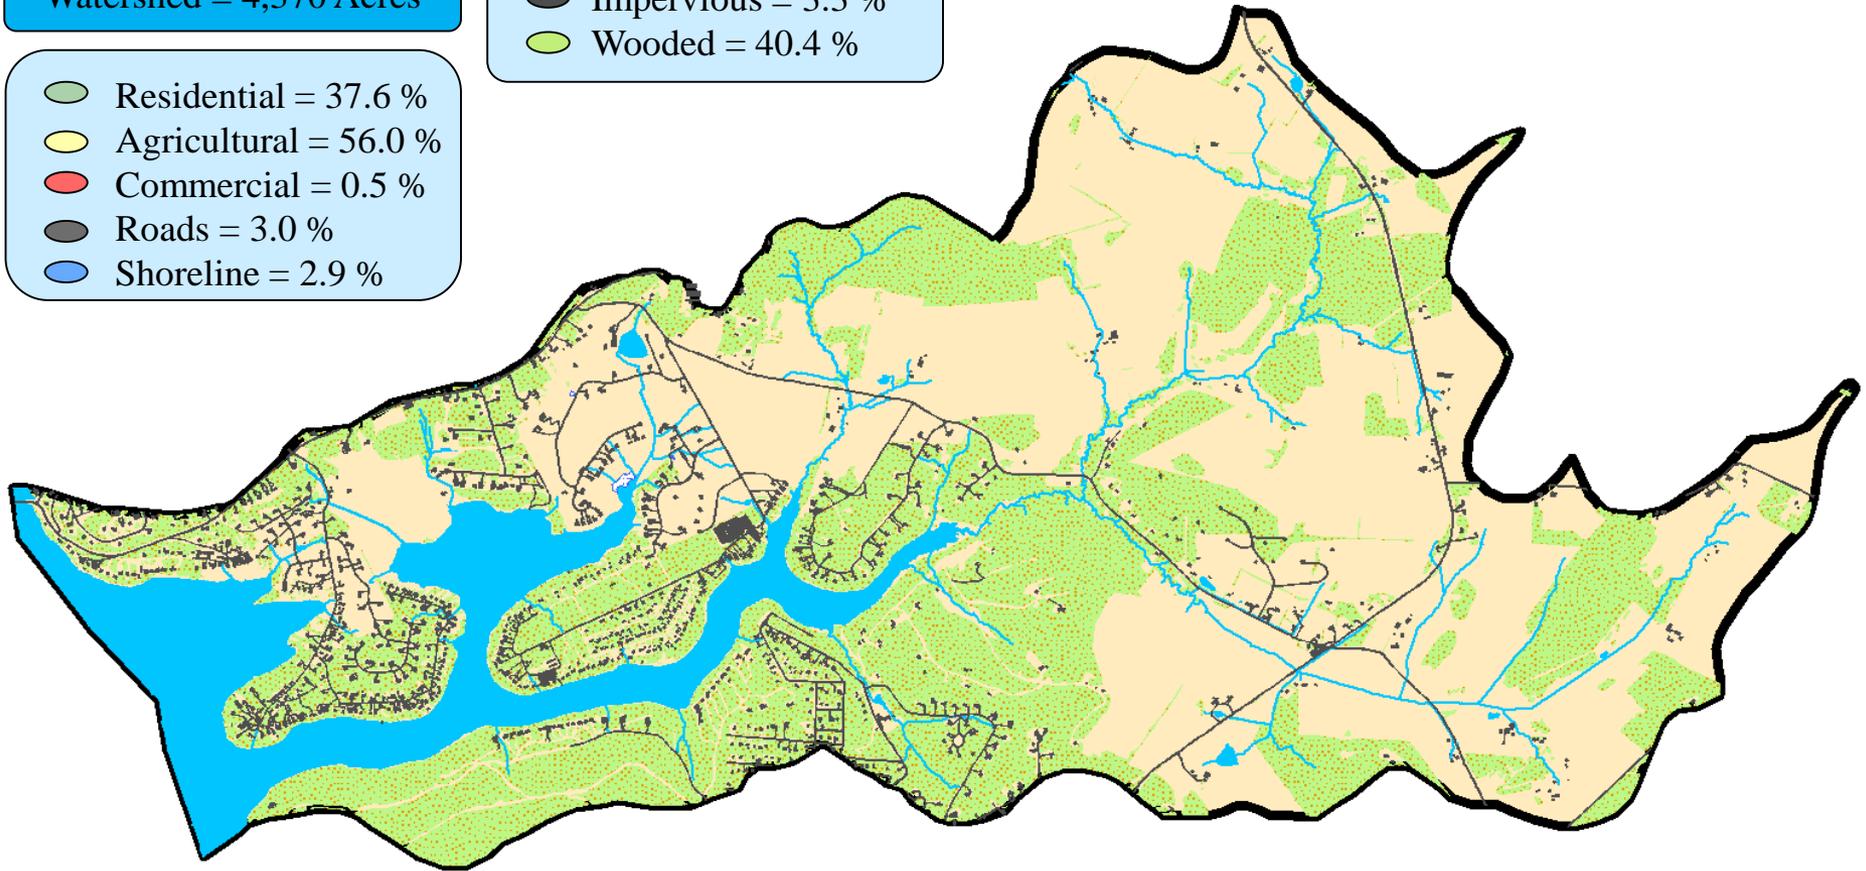
Land Use

Watershed = 4,370 Acres

Impervious = 3.3 %

Wooded = 40.4 %

Residential = 37.6 %

Agricultural = 56.0 %

Commercial = 0.5 %

Roads = 3.0 %

Shoreline = 2.9 %

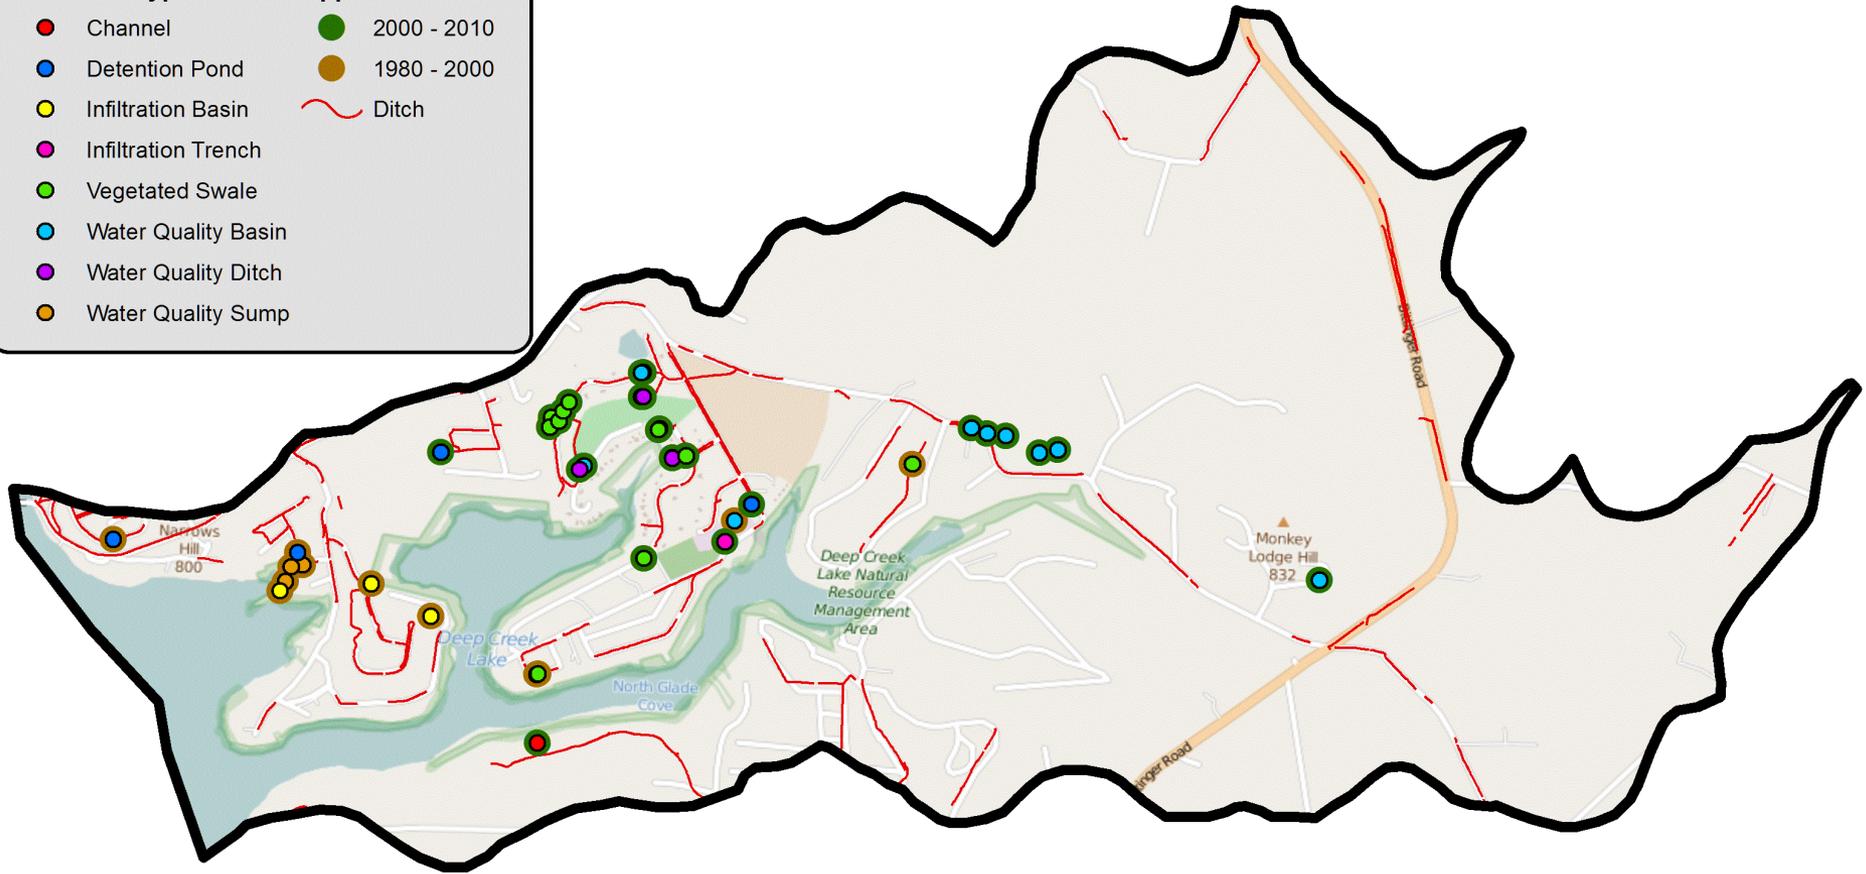
Storm Water Management

Structure Type	Approved Permit
● Channel	● 2000 - 2010
● Detention Pond	● 1980 - 2000
● Infiltration Basin	— Ditch
● Infiltration Trench	
● Vegetated Swale	
● Water Quality Basin	
● Water Quality Ditch	
● Water Quality Sump

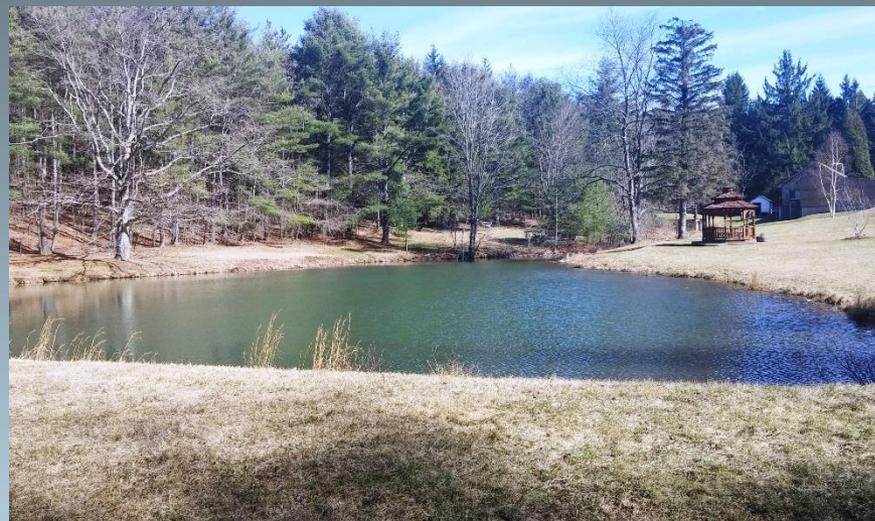
NGR Watershed Assessment SWM Conversion Prioritization

Pond Condition: Check all that apply

Riser: Good Condition Damaged

Embankment No problems Trees on Embankment Erosion
 Holes in embankment

Vegetation Wetland vegetation Trees Base soil erosion
Pond bottom

Fence/gate Fence in good condition Fence needs repair No Fence
 Gate locked Gate unlocked No Gate

Conversion Potential:

Pond field type conducive to conversion: Yes No

Pond is on line: Yes No

Ease of access: Easy Moderate Difficult

Flow routing: Short Flow Path Long Flow Path

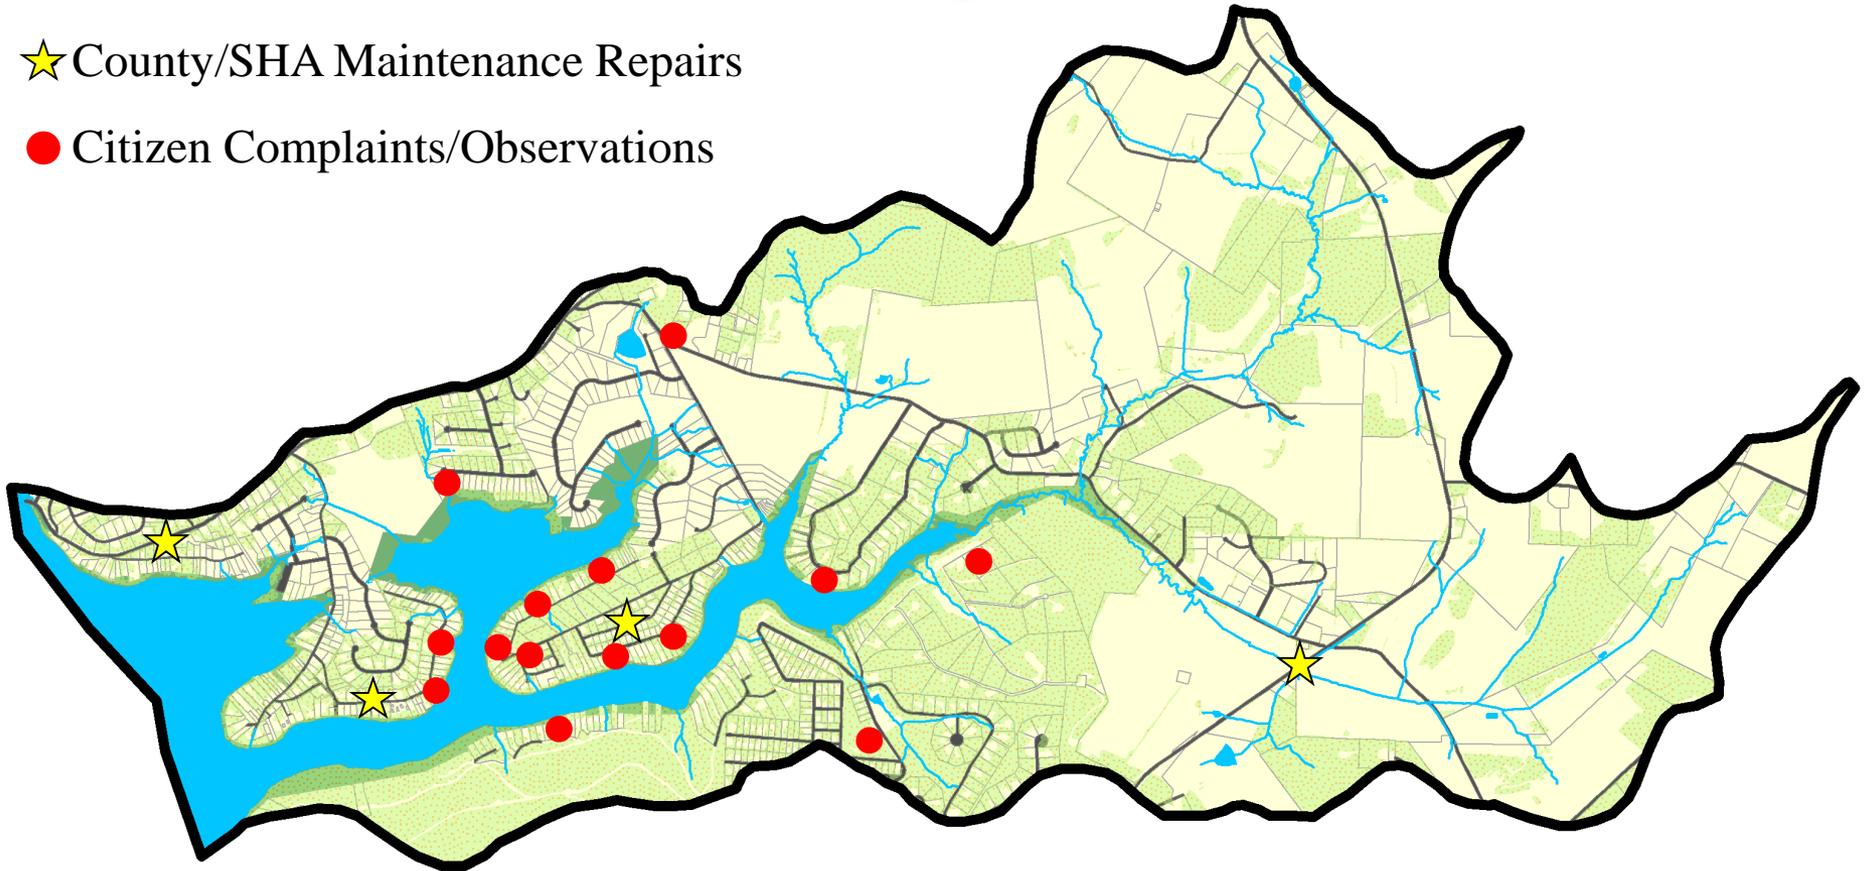
Known Pollutant Sources and High Maintenance Areas

★ County/SHA Maintenance Repairs

● Citizen Complaints/Observations

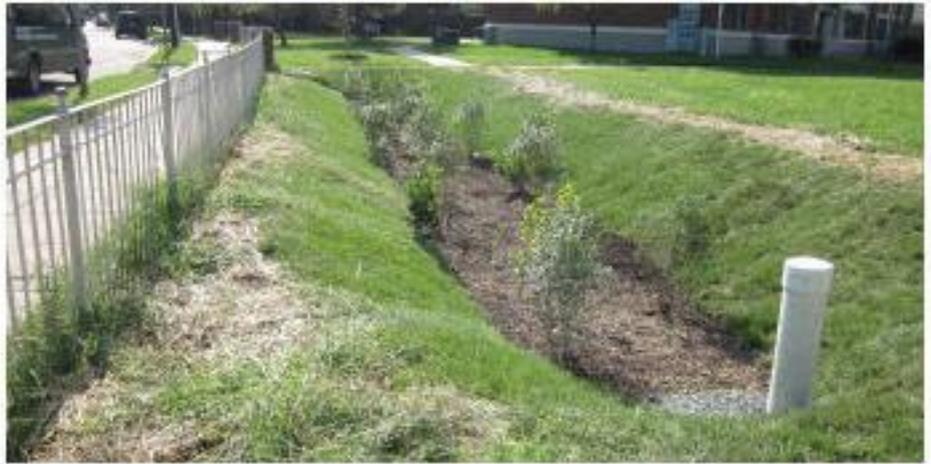
BIORETENTION IN OPEN AREA

Runoff drains into the bioretention planting from the surrounding area (sidewalks, roadways, or grass). The size and shape can fit the available space.

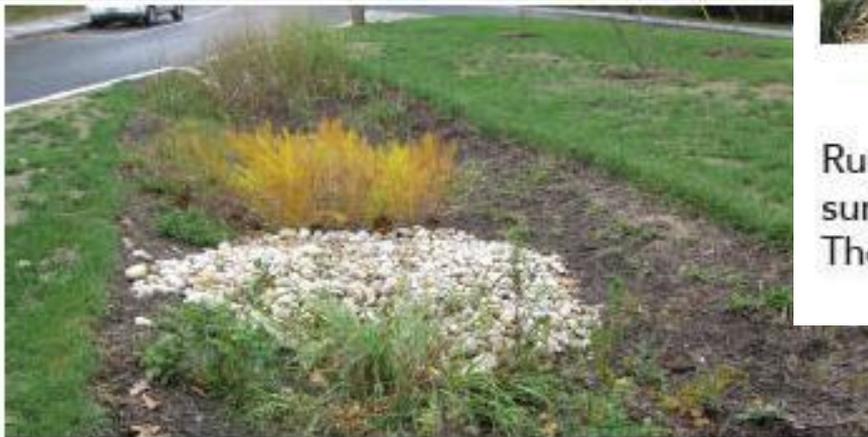
BIOSWALE

Runoff flows directly into a bioswale which is located adjacent to the street. A bioswale will follow the slope of the street and may have check dams to make the grade step down.
